**Technical Assistance to North West
Agricultural Development Project (II^o Phase),
Somalia**

July 1987

Consultancy Report on
Hydrogeological Short Term Mission
May - June 1987

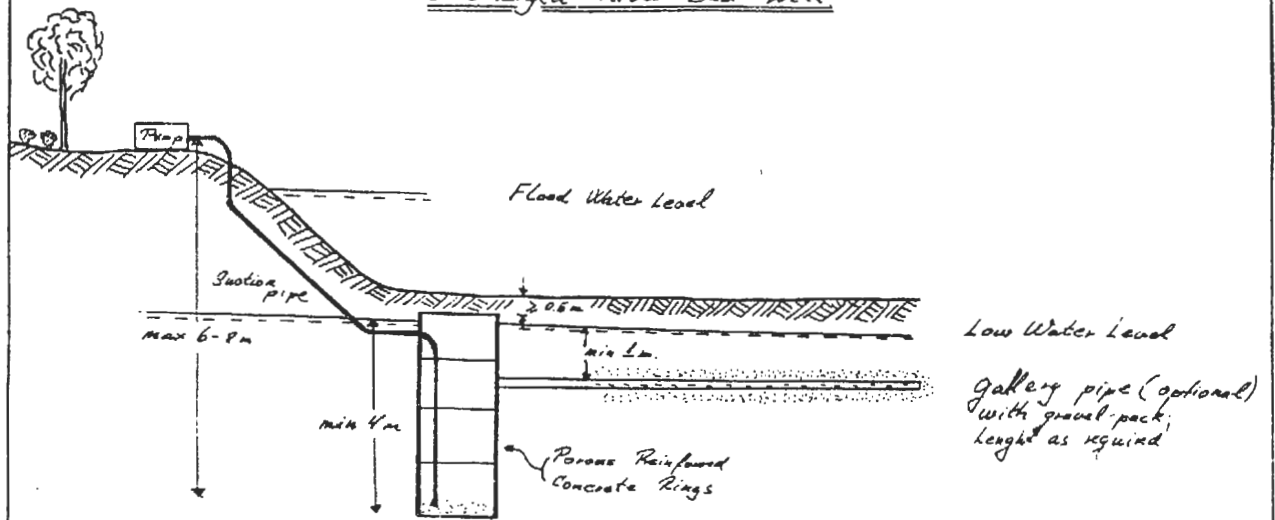
Fig 2.1

Submerged River - Bad Well

Where possible, new wells should be constructed as submerged river-bed wells, where required supplied with infiltration galleries. This type of well has several advantages to river-bank wells:

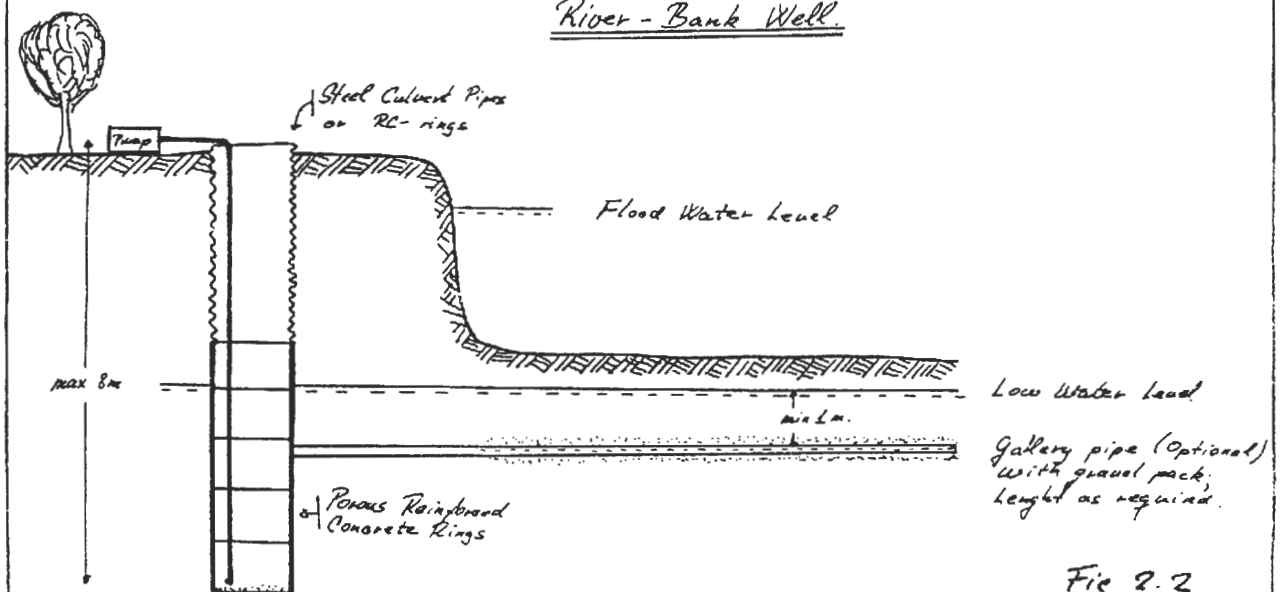
Fig 2.2

River - Bank Well

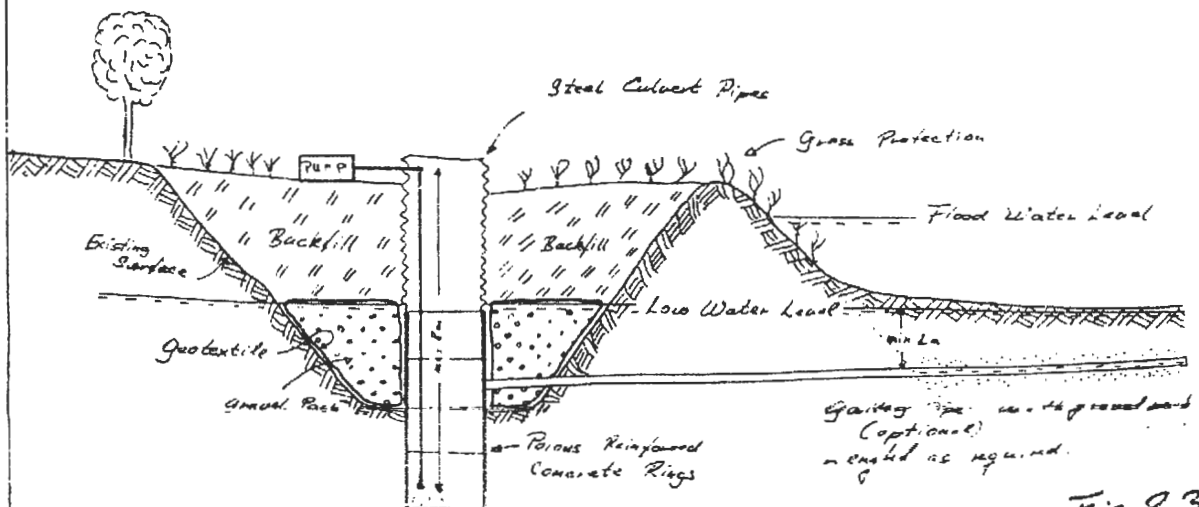
Fig 2.3

Rehabilitated Well.

For existing wells to be rehabilitated, the procedure is more or less equivalent to above, apart from the condition that the aquifer has already been met and final depth is likely to be more precisely known before the construction.

The first concrete ring is placed in the bottom of the existing well, which in the case of very deep wells may cause some practical problems. If the installation of concrete rings is not possible due to weight etc, corrugated culvert pipes may be used instead. In this case the pipes must be perforated and where possible wrapped with geotextile. The excavation/subsidence process is commenced from here and is continued until sufficient water continuously enters the well.

If required a superstructure of culvert pipes is built on top of the concrete rings, the original hole is filled in, and remaining slopes are stabilized with heavy grasses for protection against surface erosion and caving.
