## Temporal Analysis of Shabelle River Water-levels as Seen from Very High-resolution Satellite Images

SWALIM has analysed the temporal river level status using observed river level data and very high-resolution satellite images taken on different dates in selected towns

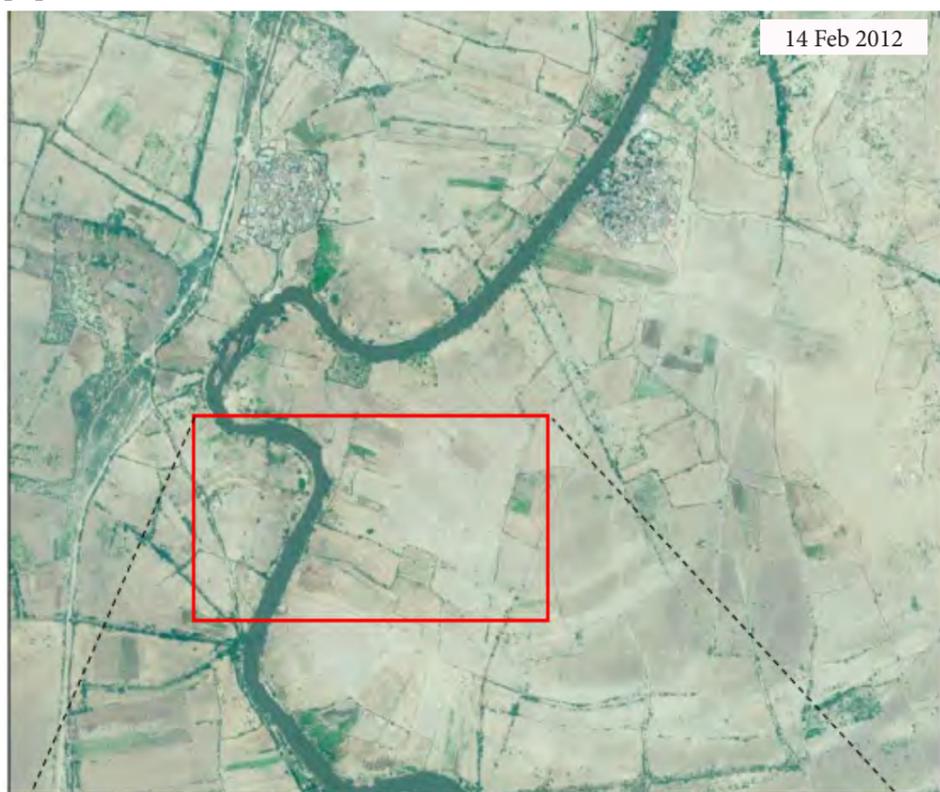
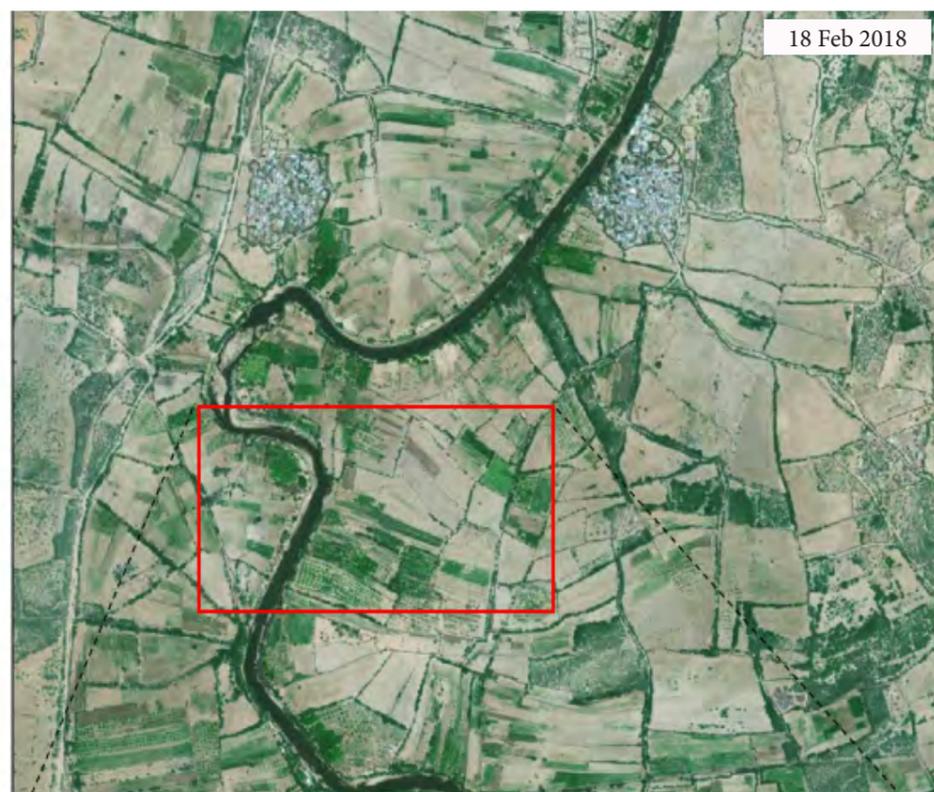
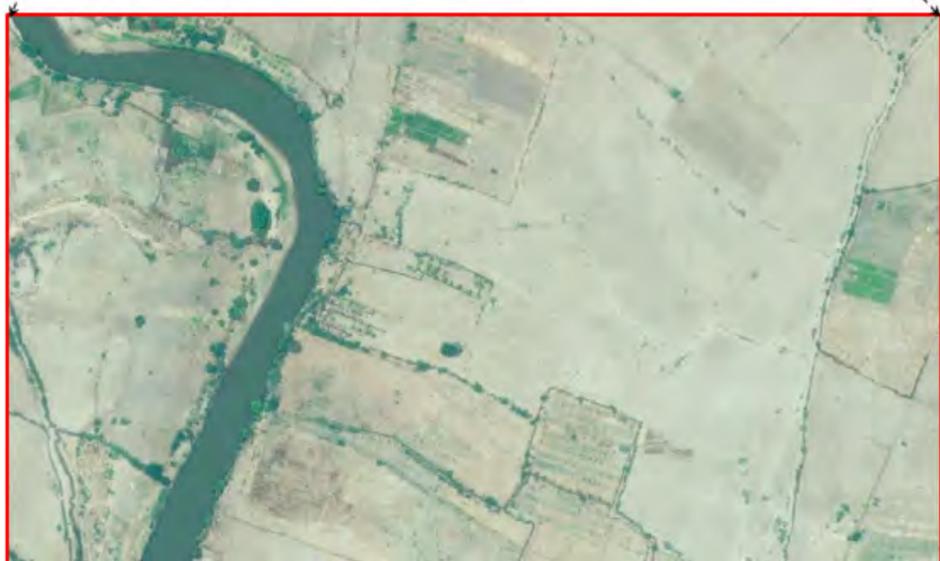
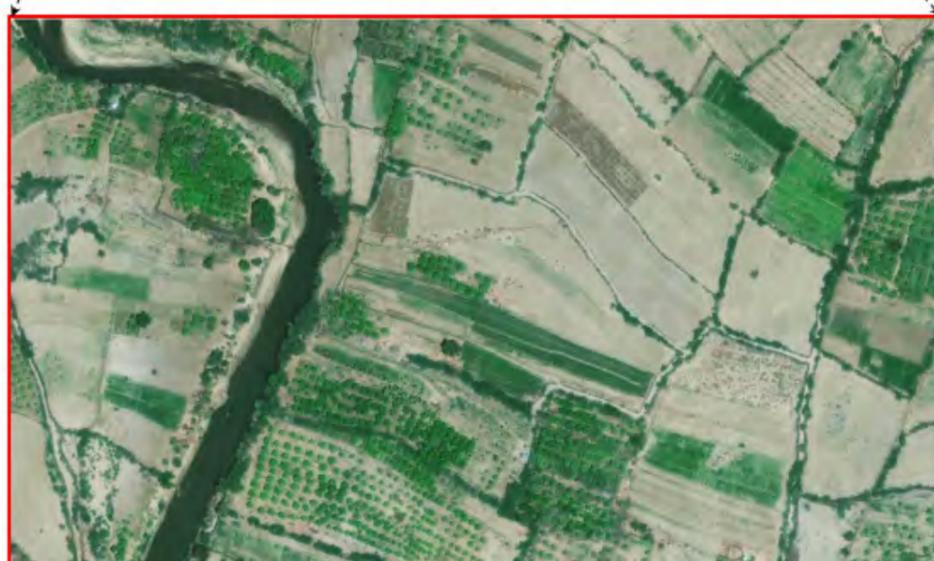
The figures above show the comparison of a GeoEye image of February 2018 (right) and a World View 2 image of February 2012 (left), depicting an area located about 2.5 km South of Belet Weyne. It is interesting to notice that the active cropped area (green) is much more extended in 2018 as compared to 2012, mainly due to a change of the agricultural practise. In 2012 the area is mainly covered by seasonal herbaceous crops (not active in February), while in 2018 the area appears to be covered by permanent tree crops (active in February), which need to be irrigated throughout the year. The red outlined inset shows a portion of the tree crops present in the area.

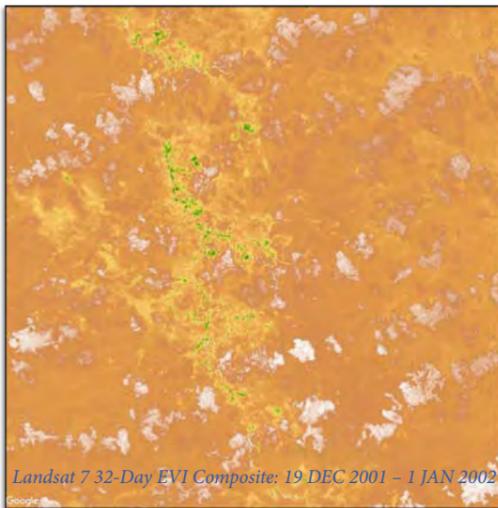
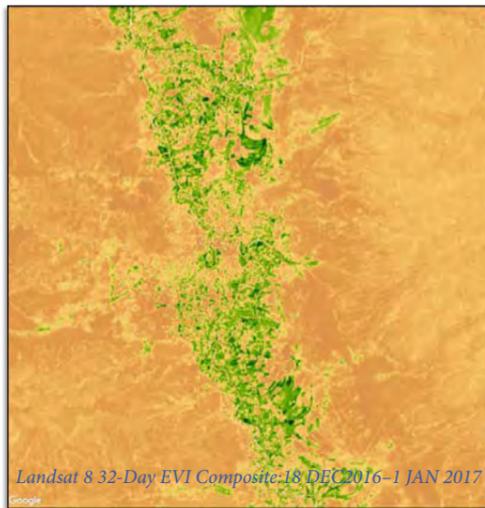
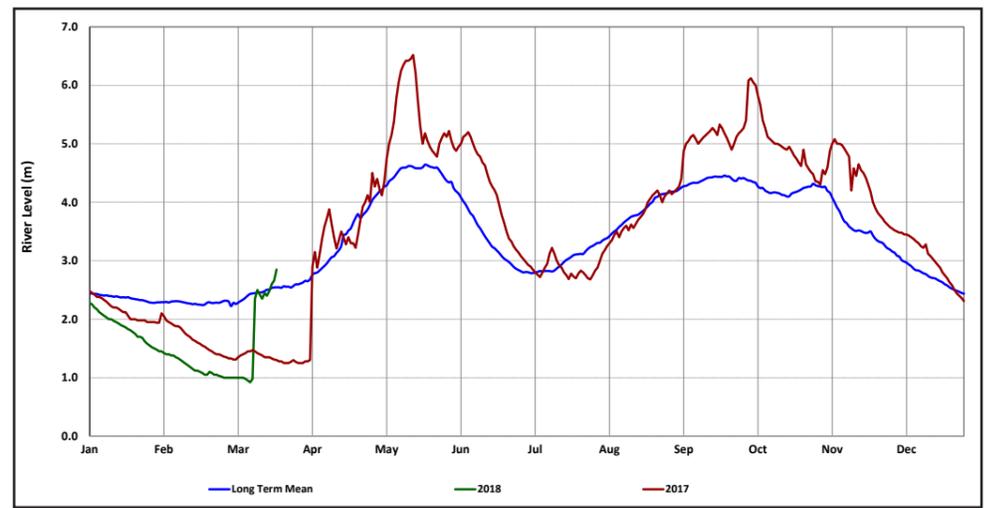
The overview of the agricultural area in Belet Weyne shows that in Dec 2016 the active irrigated crops (green) covers a bigger area as compared to 2001. With population growth and resettlements in riverine areas it is expected there will be more agricultural activities along the river with time. With no sufficient rains to irrigate the crops, more water is drawn from the river leading to reduced flow. The graph on the right shows the Shabelle river levels at Belet Weyne in 2018 compared to the 2017 levels and the long term mean.

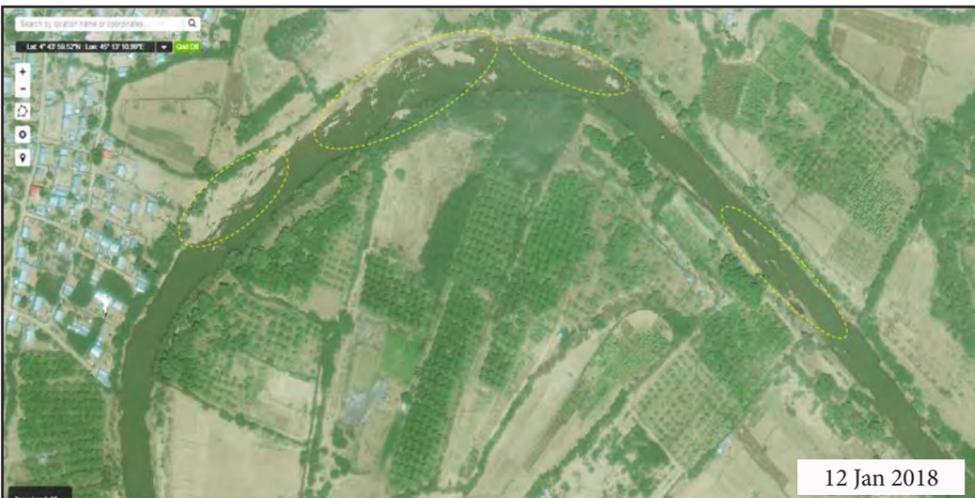
The image shows that river level is very low, as evidenced by the presence of sand deposits/river bed (yellow outlined) occurring along the river.

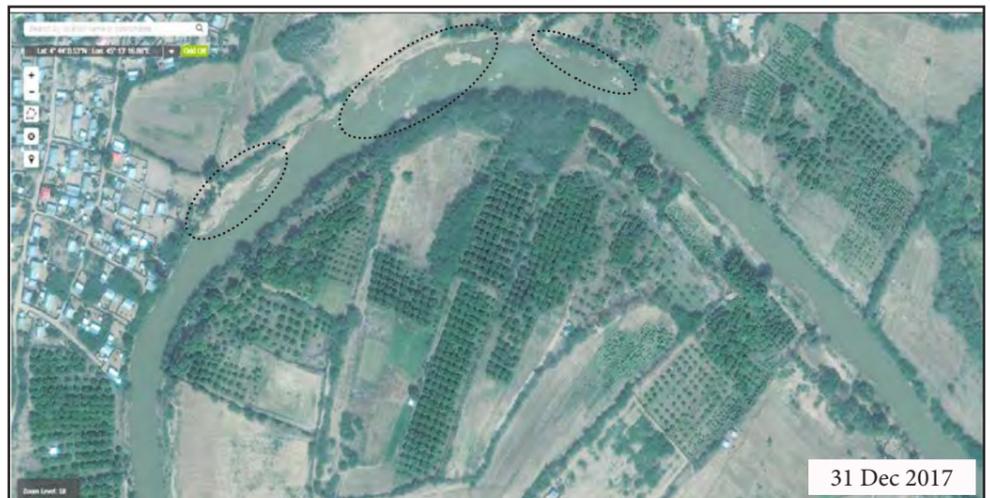
The image shows a low river level as evidenced by the presence of sand deposits/river bed (yellow outlined) occurring along the river. However, on this date the river level is higher as compared to the previous image (12 Jan 18). In fact, in some portions sand deposits either are submerged or with reduced extent.

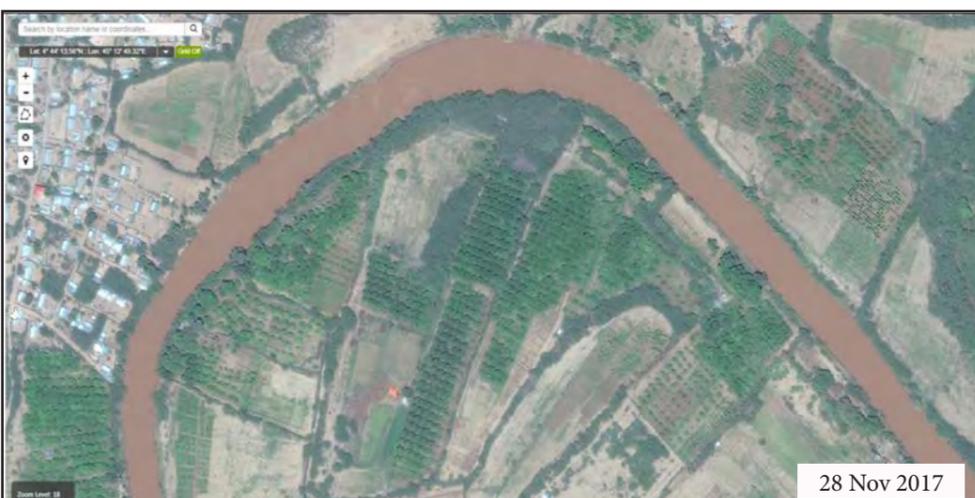
The image shows that river level is normal. The high sediment load indicated by the light brown colour of the water demonstrates the high-energy of the river flow following the Deyr rains in October and November 2017.

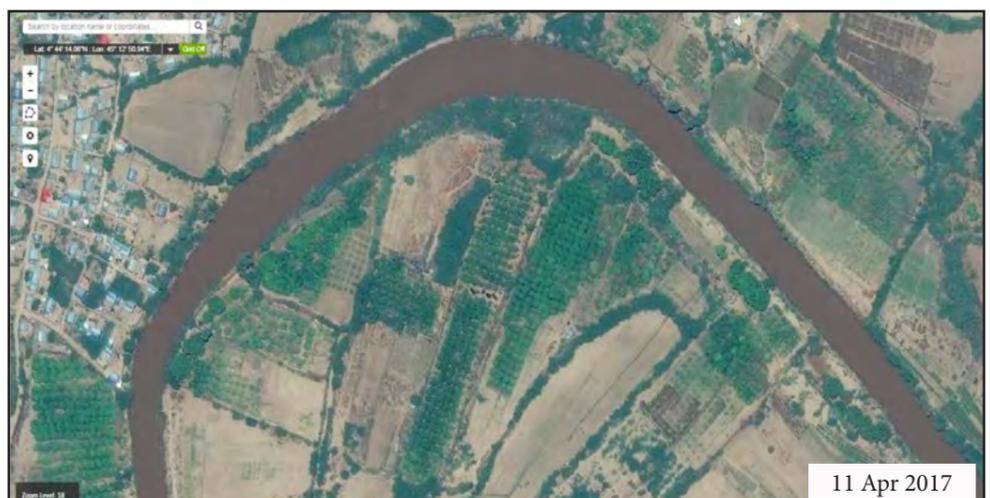
In this image, the sediment load indicated by the brown colour of the water demonstrates the high-energy of the river flow. Sand deposits visible in the previous images are not visible as they are completely submerged. April also marks the beginning of Gu rains that lead to increased river flows.

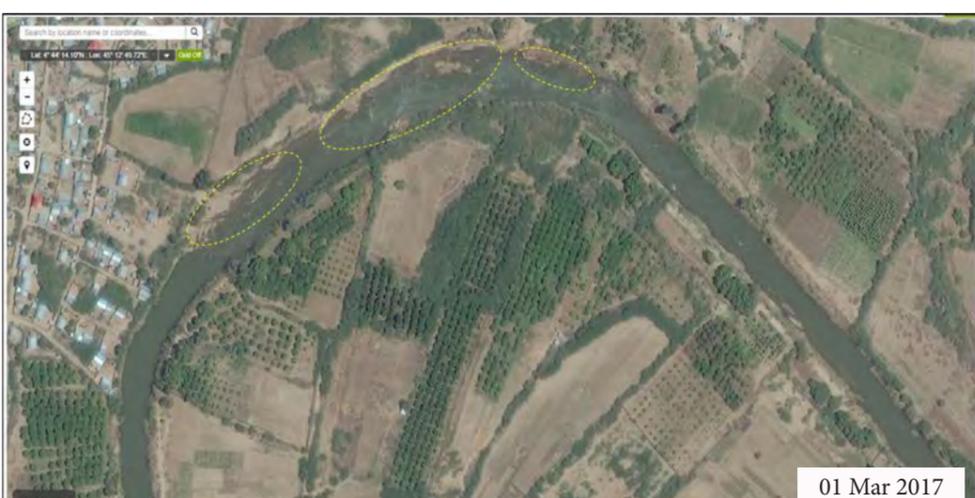
The image shows that river level is low, as evidenced by the presence of sand deposits/river bed (yellow outlined) occurring along the river. The dark green colour of the river indicates sediment load hence the low-energy of the river flow.

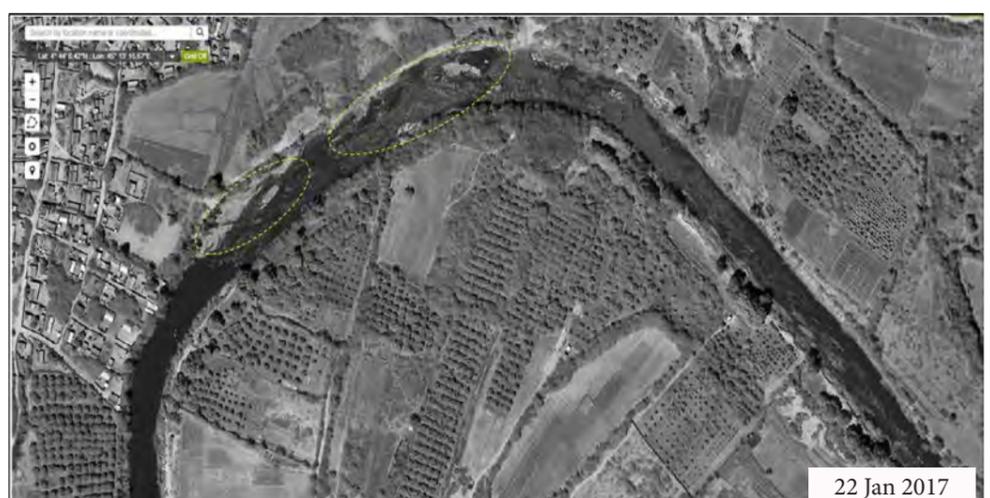
The image shows that river level is low, as evidenced by the presence of sand deposits/river bed (yellow outlined) occurring along the river. However, the river level on this date seems to be slightly higher as compared to the previous image.

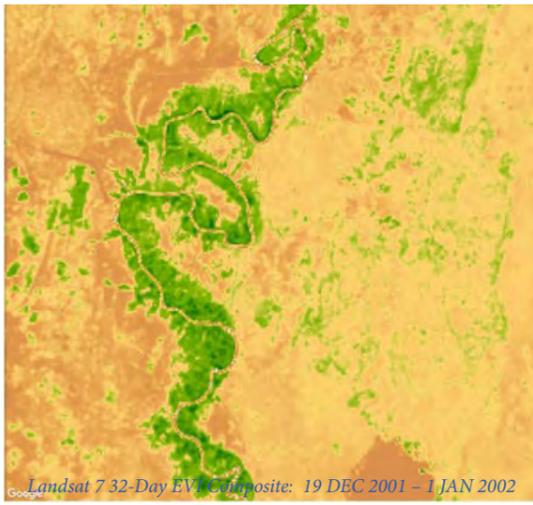
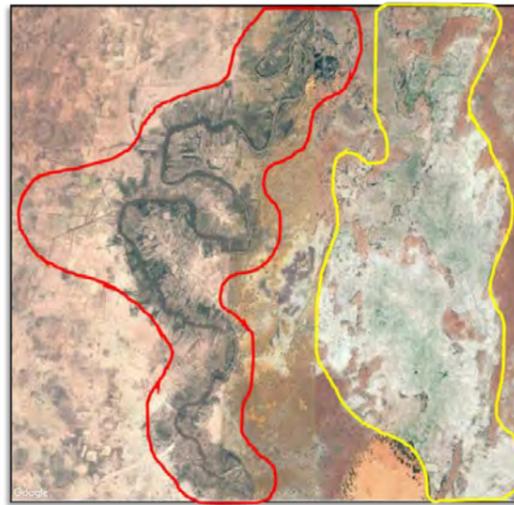
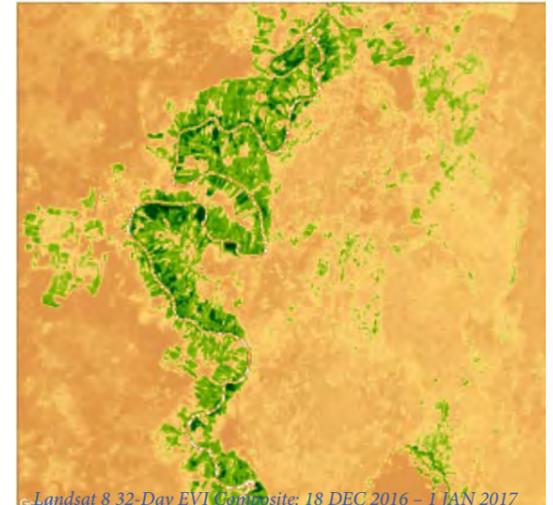
The overview of the agricultural area in Bulu Burti shows that in Dec 2016 the active irrigated crops (green) cover a bigger area as compared to 2002. We can assume that more water from the Shabelle River was diverted to the agricultural areas in Dec16 - Jan2017, affecting the river level. In the middle image outlined in red is the agricultural area under irrigation and outlined in yellow is the rain fed agricultural area. A decrease of active rain fed agriculture as of Dec 2016 when compared to Dec 2001, indicates a shift to irrigated agriculture when rainfall does not allow to grow crops.

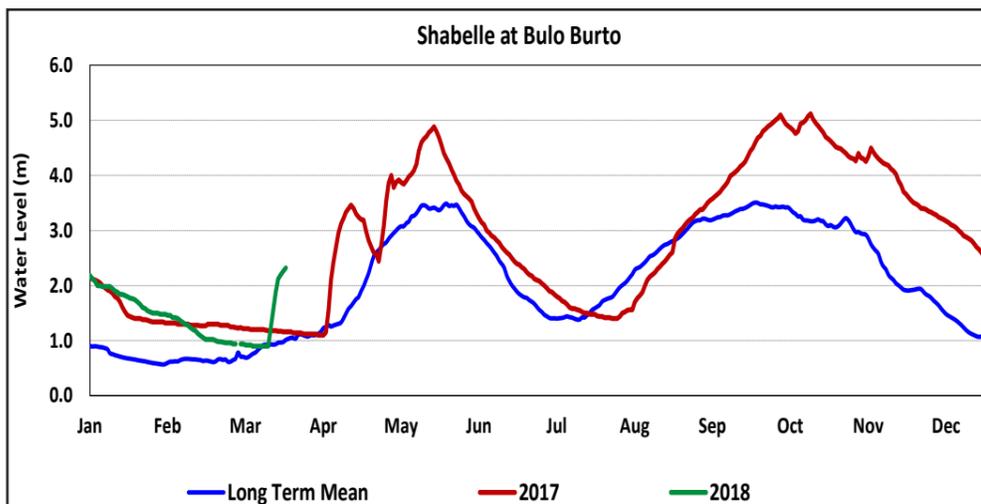
The graph shows the current river level compared to the 2017 level and the long term mean.

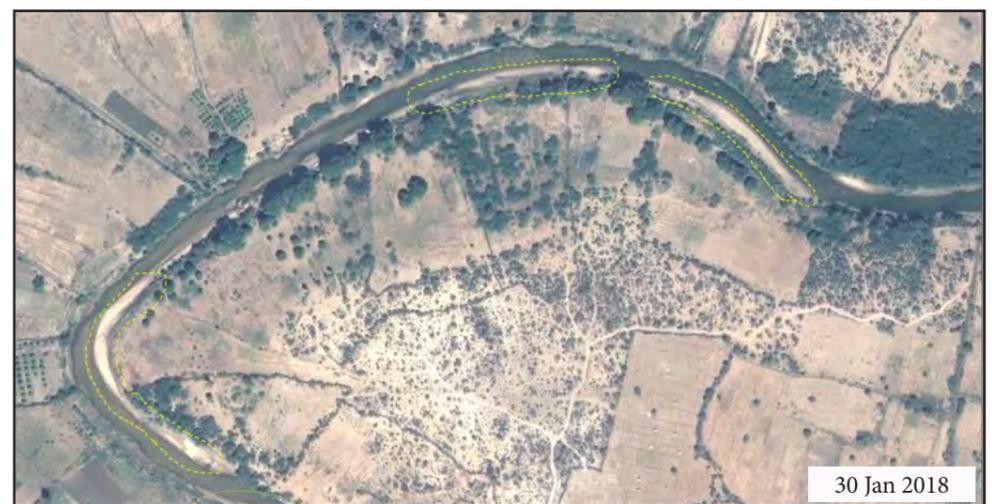
The image shows that river level is very low, as evidenced by the outcropping of sand bars along the embankment (yellow outlined).

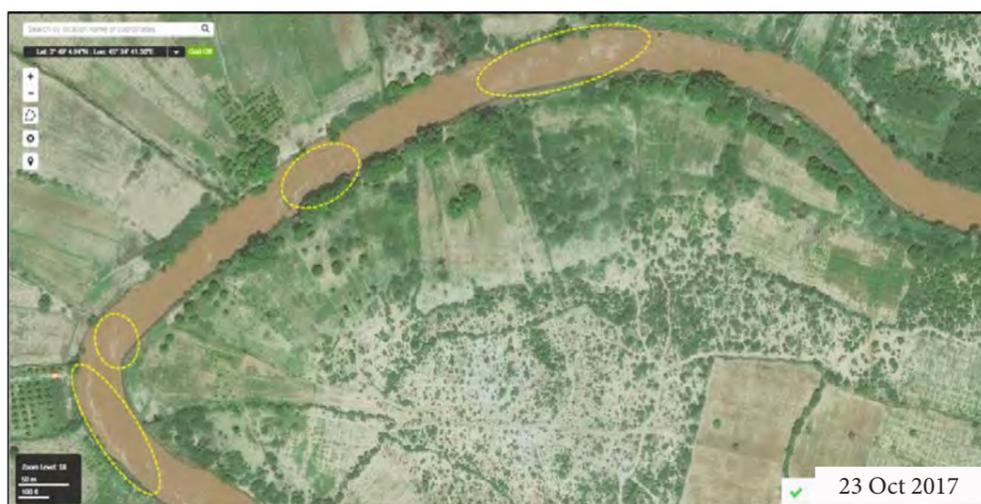
The image shows that river level is high. In fact sand bars along the embankment are submerged. The sediment load is high meaning that the energy of the water increased, as indicated by the ripples on the water surface (yellow outlined).

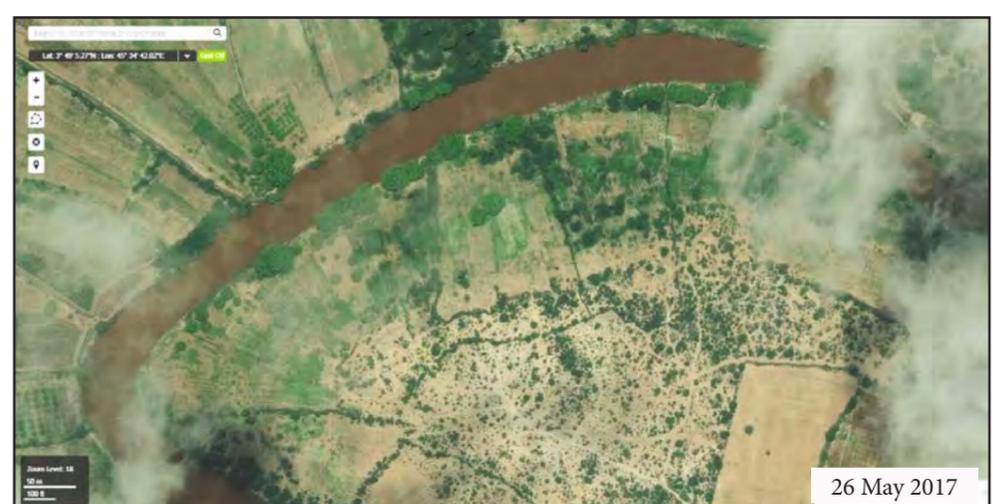
The image, though a bit hindered by clouds, shows that river level is high. Sand bars along the embankment are completely submerged. The energy of the water stream is normal as no ripples on the water surface are noted.

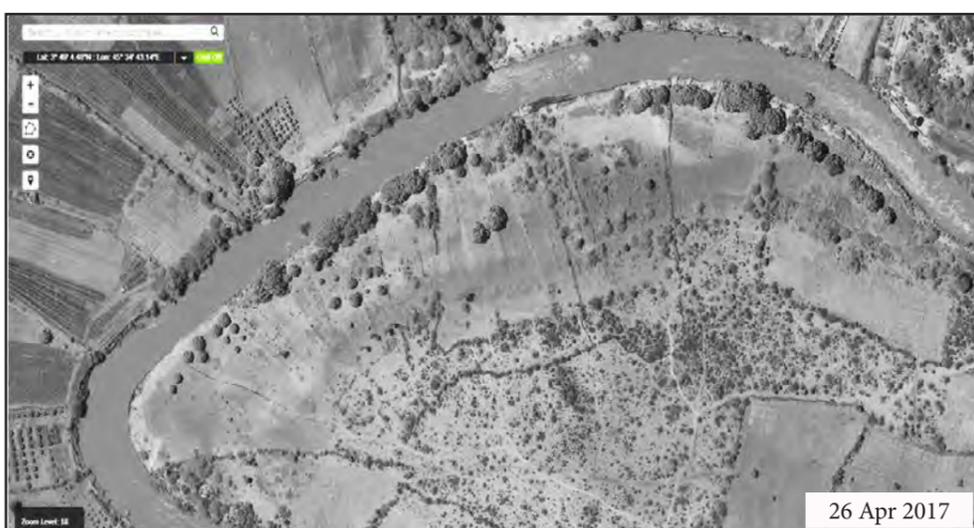
The image shows that river level is lower as compared to May 2017. Portions of sand bars along the embankment (yellow outlined) are visible. The energy of the water stream is high as indicated by the ripples on the water surface.

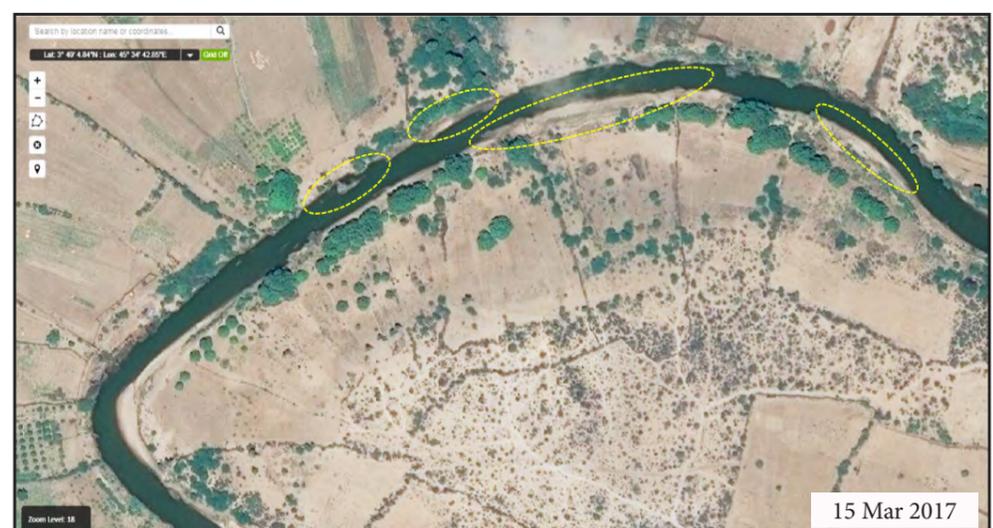
The image shows that river level is very low, as evidenced by the outcropping of sand bars along the embankment (yellow outlined). The width of the river has decreases as compared to the previous images.

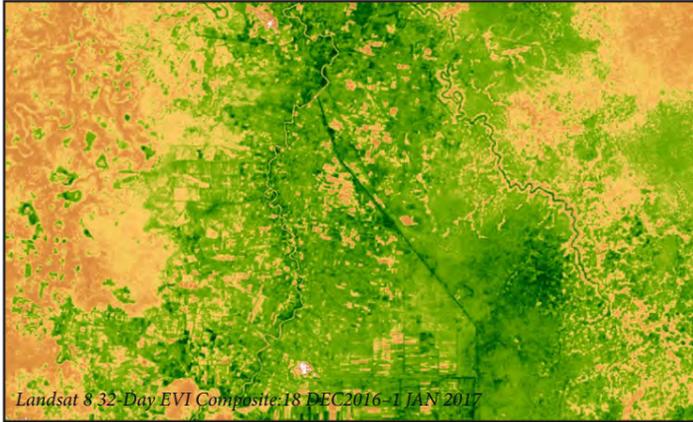
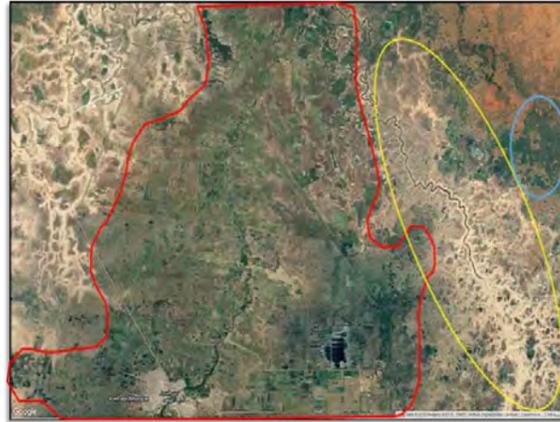
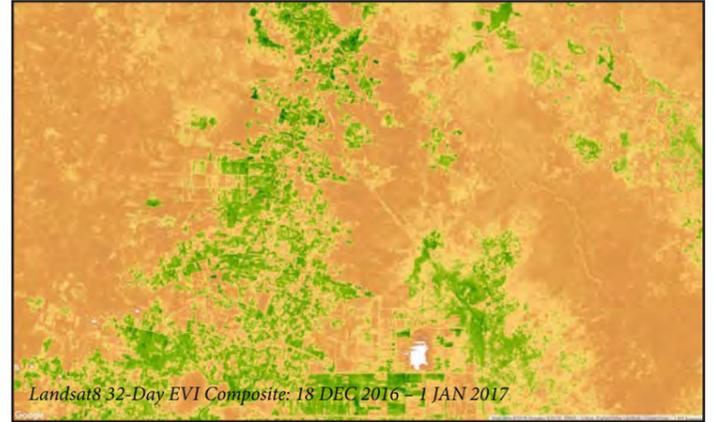
The overview of the agricultural area in Jowhar shows that in 2001 the active crops (green) cover a much bigger area as compared to Dec 2016. We can assume that this is the effect of an increased use of water upstream, which has affected water availability in Jowhar and downstream. In the middle image, outlined in red is the agricultural area under irrigation, in yellow an area made of a mixture of agriculture and natural vegetation. Most of the agricultural land is rain fed and outlined in blue is natural vegetation. There is a dramatic decrease of active rain fed agriculture as of Dec 2016 indicating a failure of seasonal rain fed crops, in Jowhar.

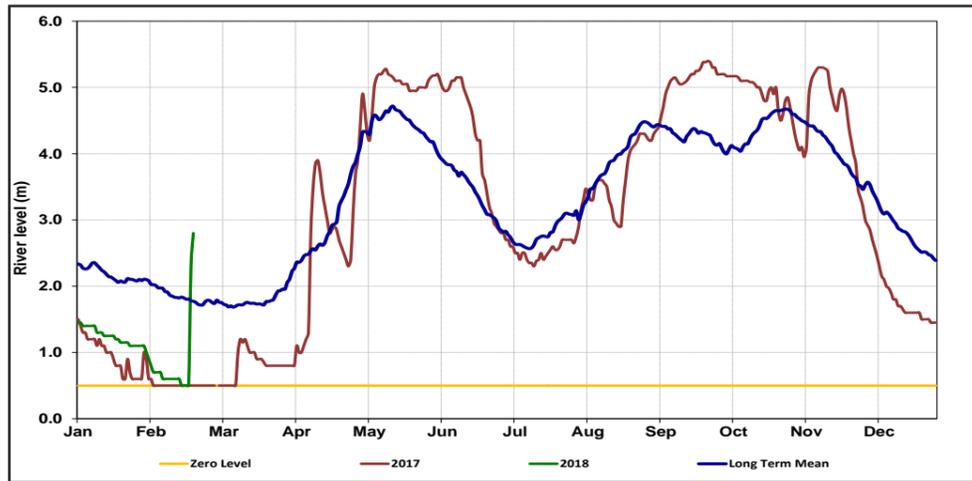
The graph shows the current river level compared to the 2017 level and the long term mean.

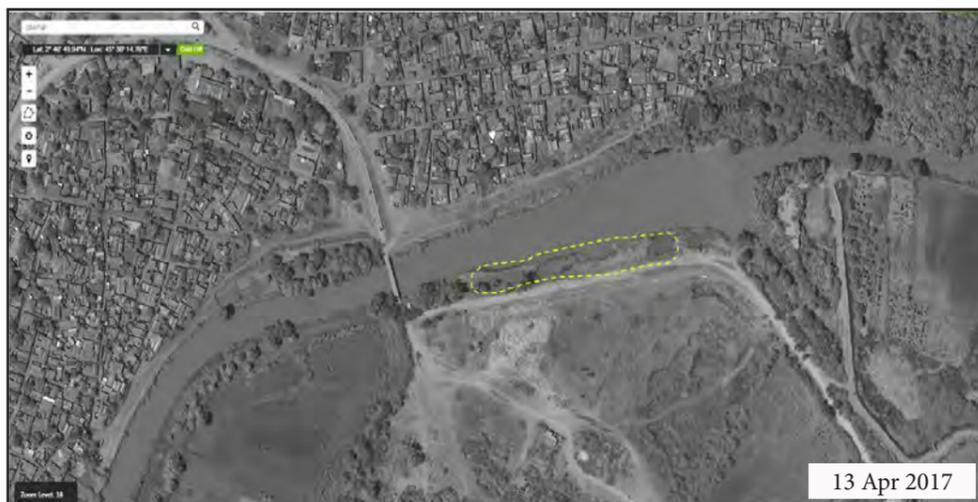
The image shows that river level is normal to high, the weir is completely submerged and portion of sand banks, which are generally outcropping, are submerged (yellow outlined).

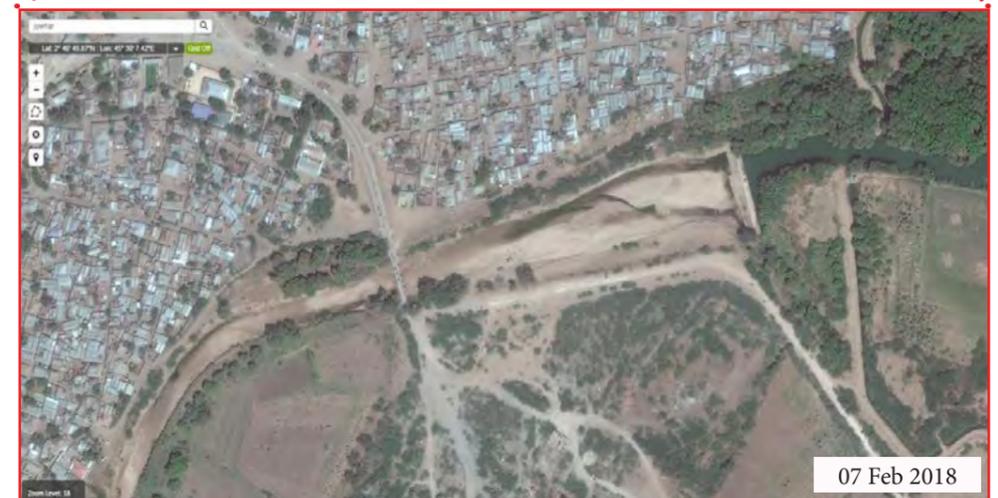
The image shows the weir in Jowhar. Downstream of the weir the river is dry as evidenced by the outcropping of the river bed. The two canals upstream the weir are active as they are providing water to the surrounding irrigated area. However, the amount of irrigated land is confined just along the primary canal, as shown with yellow outlined circles in the image showing the overview of the area. It is also noted that the majority of fields irrigated by the canals downstream the weir are not cropped.

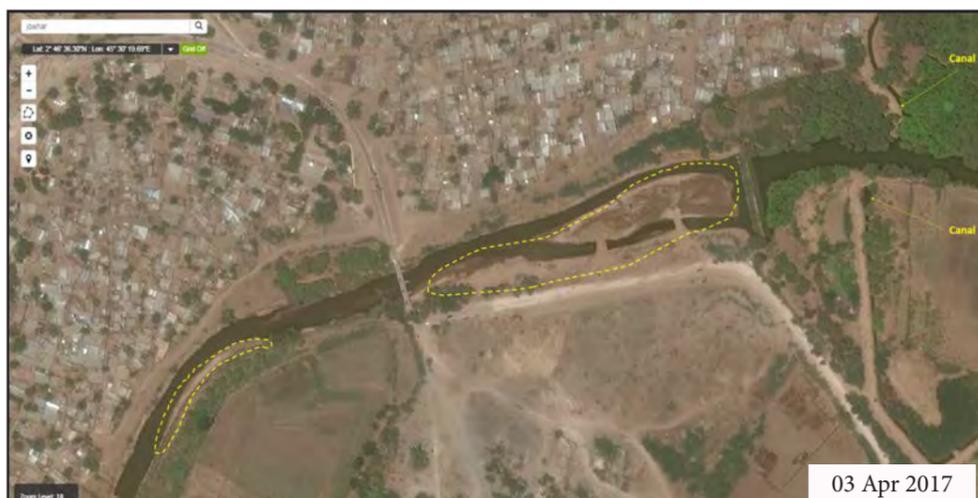
Similarly to December 2017, the image shows that river level is very low, as evidenced by the outcropping of a portion of the river bed downstream the weir and sand banks (yellow outlined). The two canals are active.

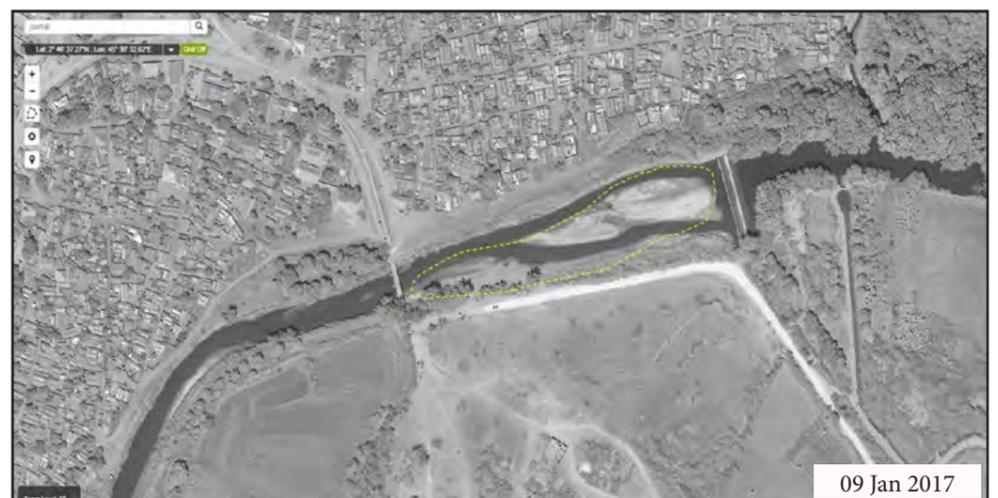
Similarly to April 2017, the image shows that river level is very low, as evidenced by the outcropping of a portion of the river bed downstream the weir (yellow outlined).
